Project Number: 19-009

Subject: 301 Mission Retrofit Monitoring Report 016: Results as of August 18, 2021

Millennium Tower Perimeter Pile Upgrade: Instrumentation Monitoring Data City and County of San Francisco, California

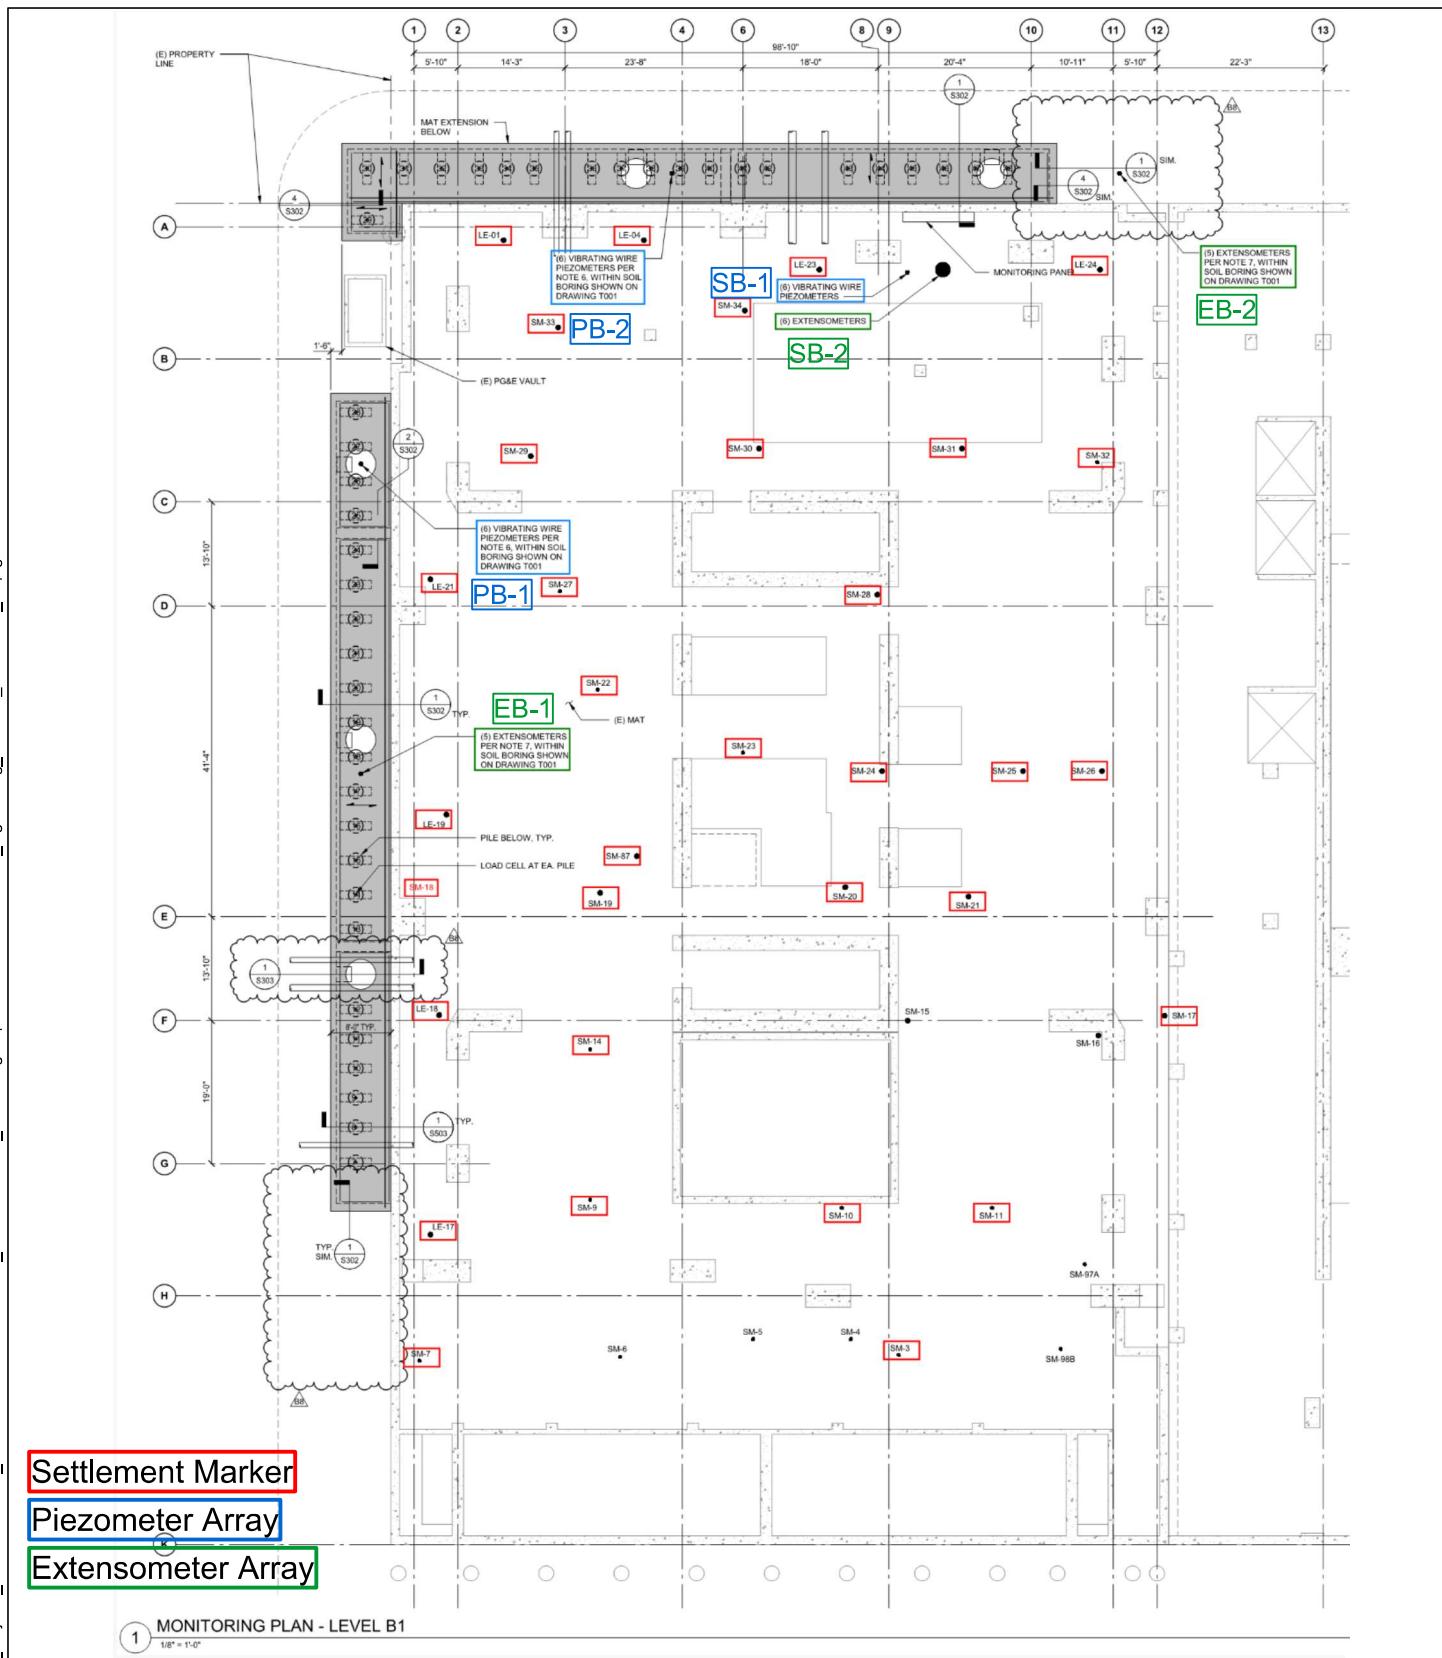
Project No: 19-009.00 Date: 7/26/2021 Created By: NBW Checked By: DGM Figure No: 016-01A

INSTRUMENT LOCATION MAP SETTLEMENT MARKERS, PIEZOMETERS, EXTENSOMETERS

Figure 01 presents the instrument locations as referenced in later figures.

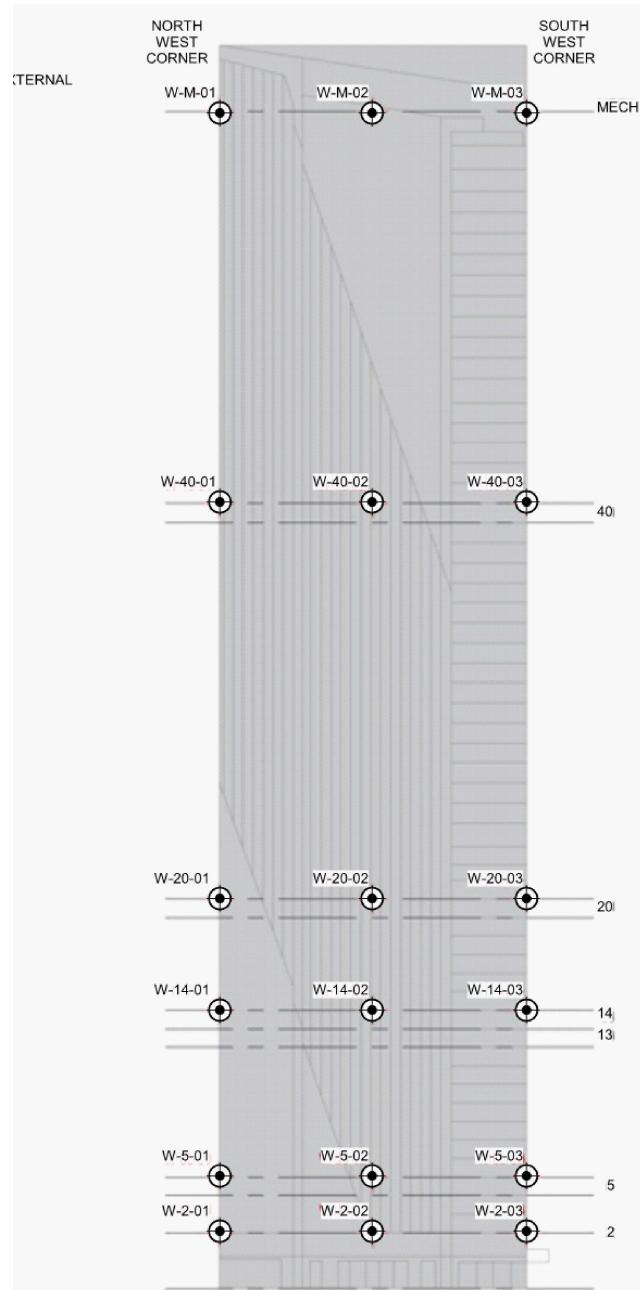
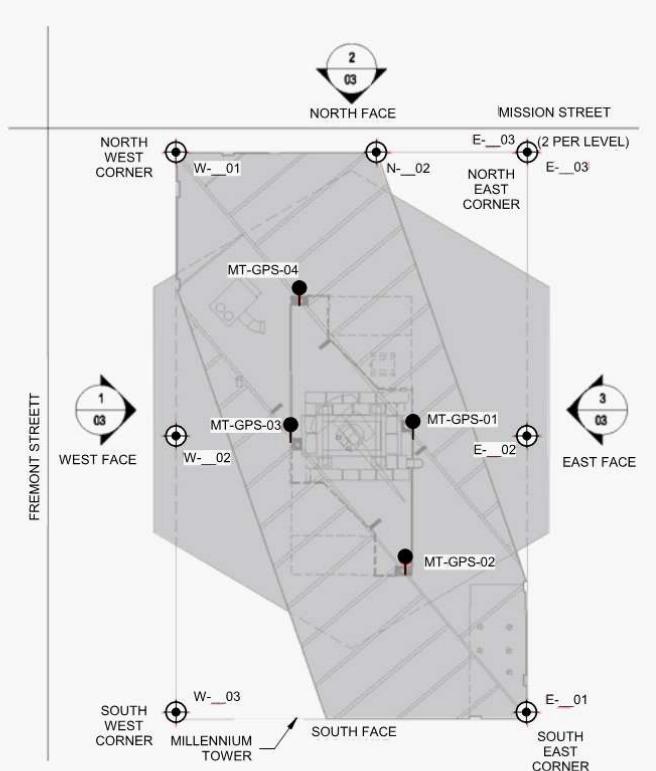
Project No: 19-009.00	Date: 7/26/2021	Created By: NBW	Checked By: DGM	Figure No: 016-01B
-----------------------	-----------------	-----------------	-----------------	--------------------

**3 ROOF PLAN OF SURVEY PRISM
INSTRUMENTATION**

**2 WEST ELEVATION OF SURVEY PRISM
INSTRUMENTATION**

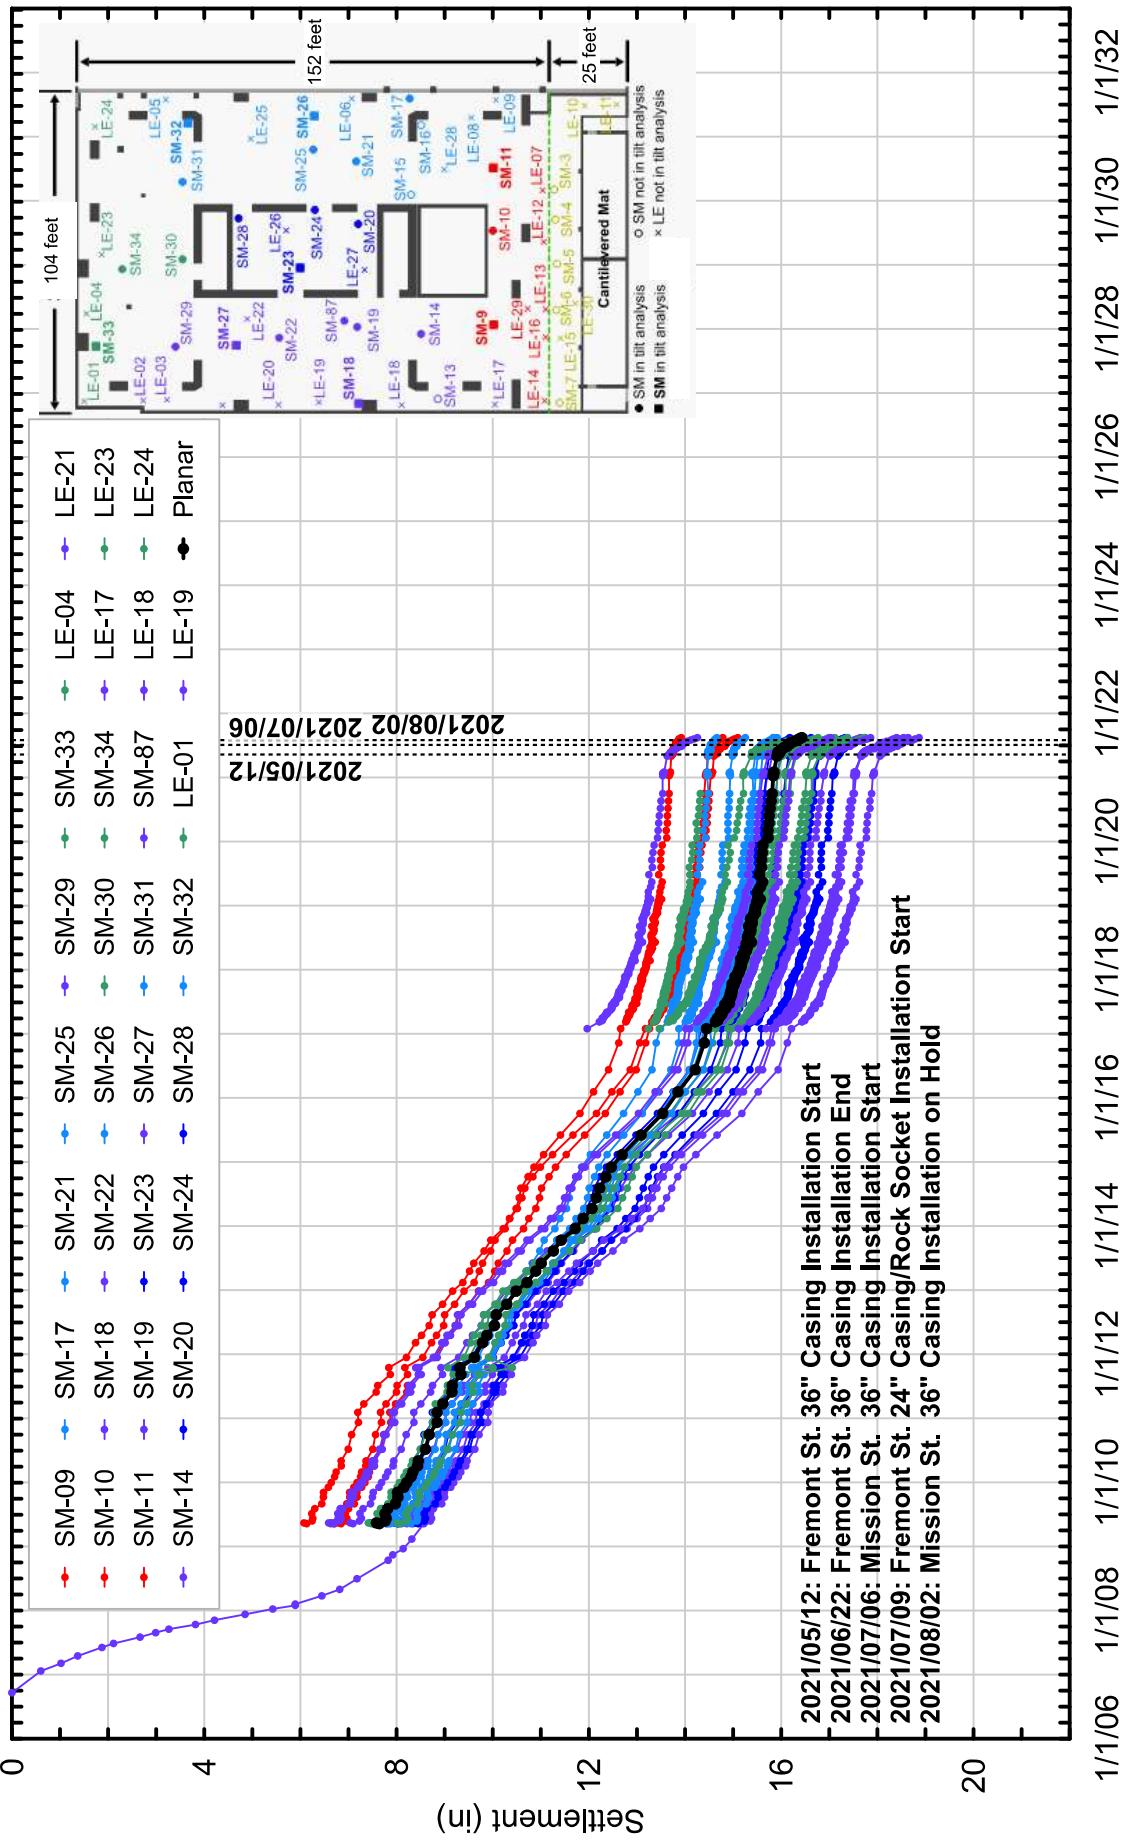
Project No: 19-009.00	Date: 8/18/2021	Created By: NBW	Checked By: DGM	Figure No: 016-02
HISTORICAL SETTLEMENT MARKER DATA

Figure 02 presents the historical settlement data interpreted from settlement markers installed on the B-1 Level of 301 Mission Tower. In addition, data from surveys performed during the retrofit are included. Figure 03A presents differential settlement data since the start of production pile installation (May 12, 2021; baseline readings on May 10, 2021) through August 2, 2021. Figure 03B presents differential settlement data since January 11, 2021, through August 16, 2021. Figure 04 presents current differential settlement contours (in inches) on August 16, 2021.

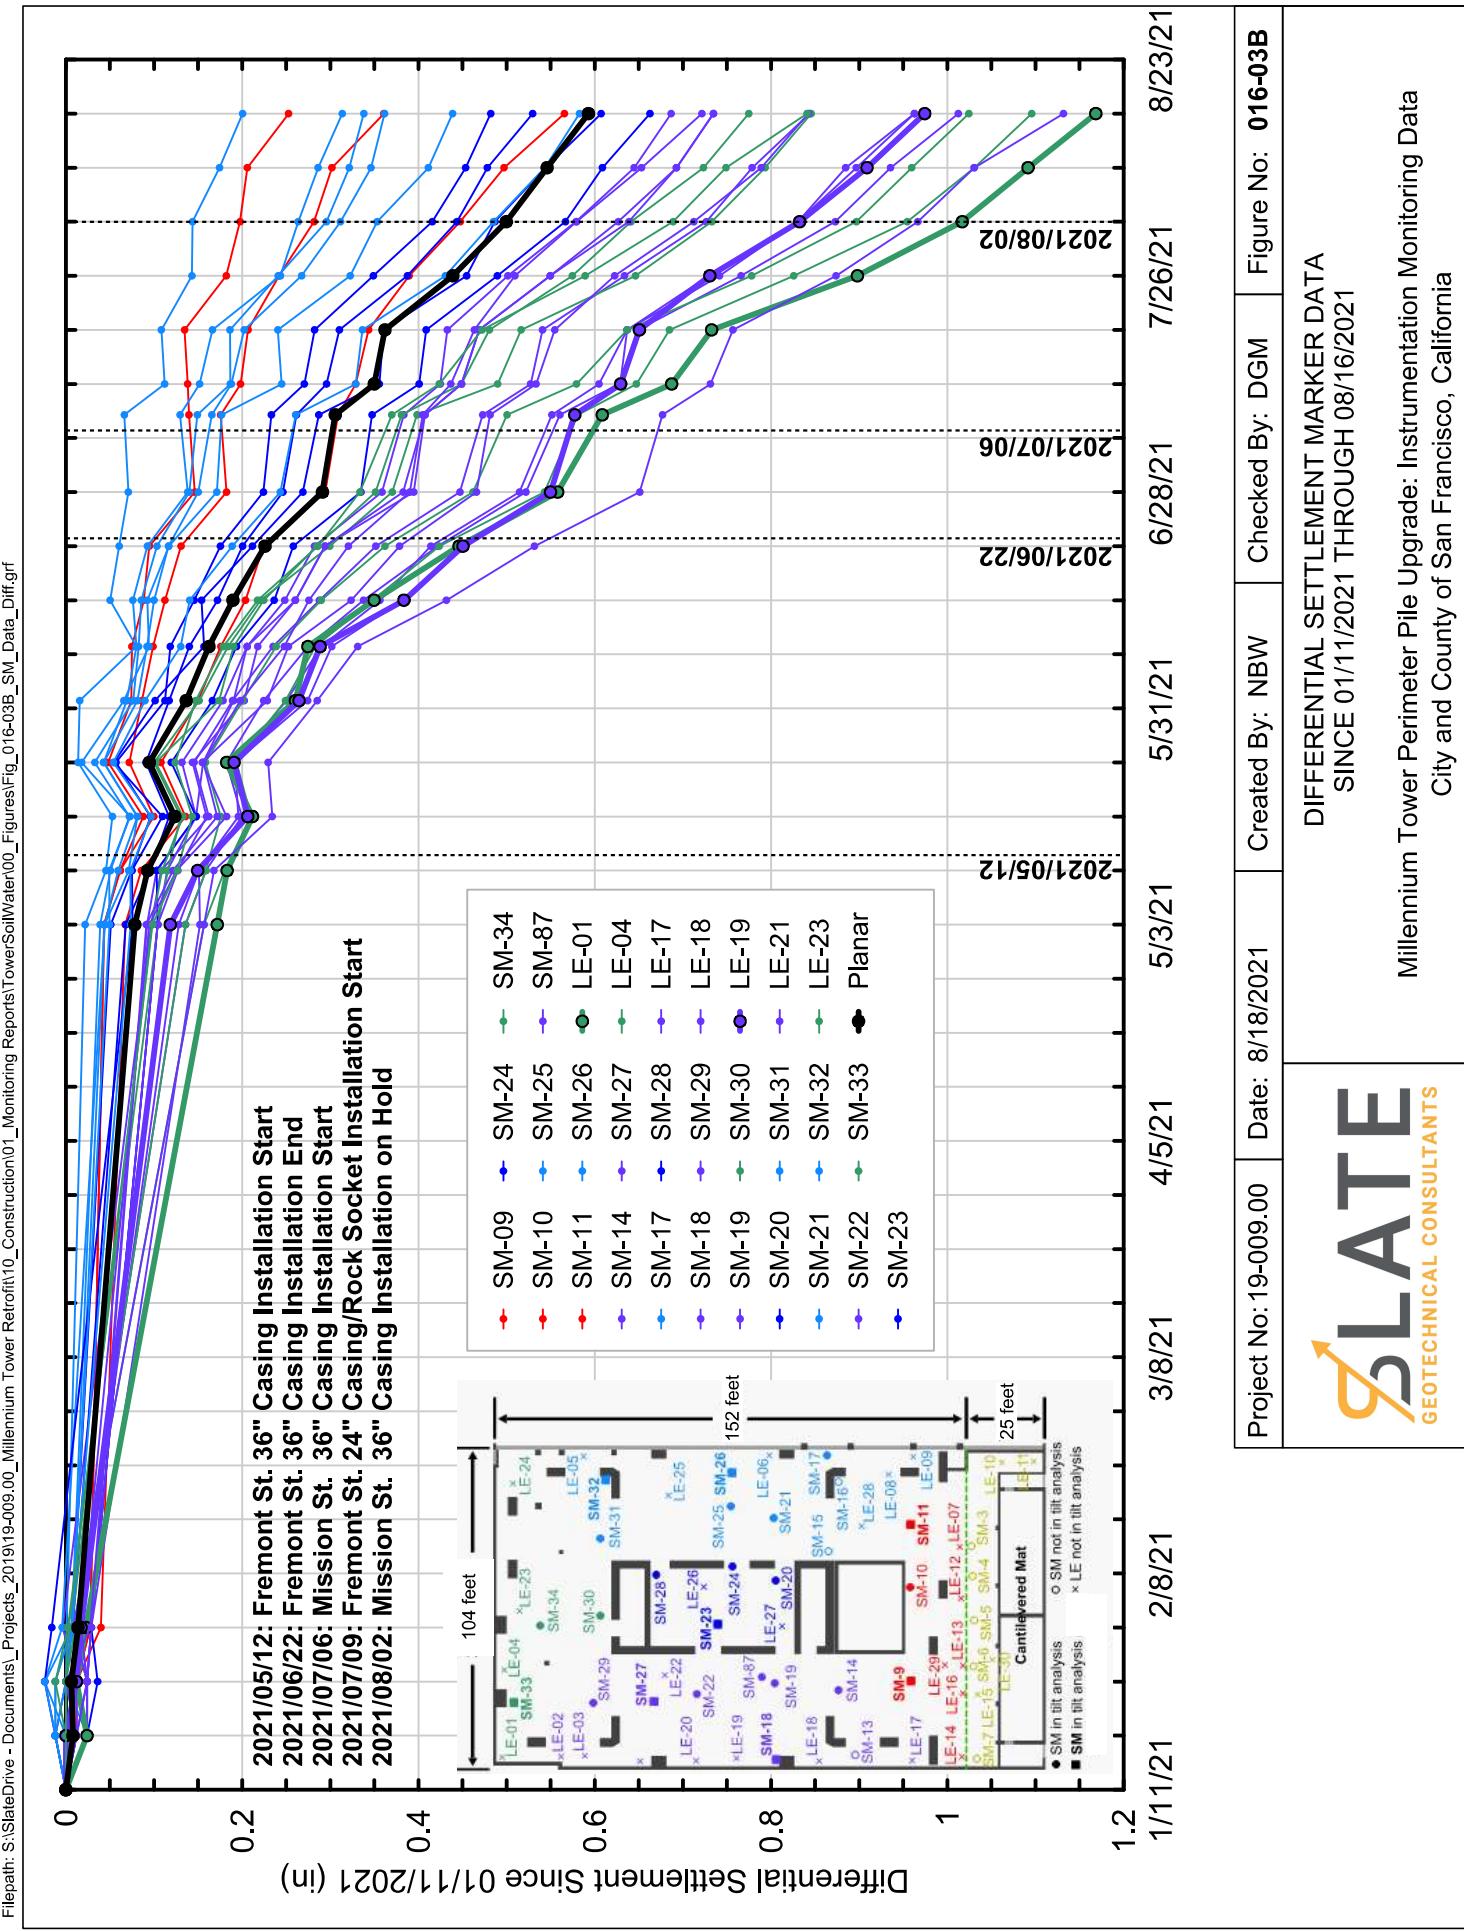
- Figure 03A – Differential Settlement Marker Data since 05/10/2021 through 08/16/2021
- Figure 03B – Differential Settlement Marker Data since 01/11/2021 through 08/16/2021

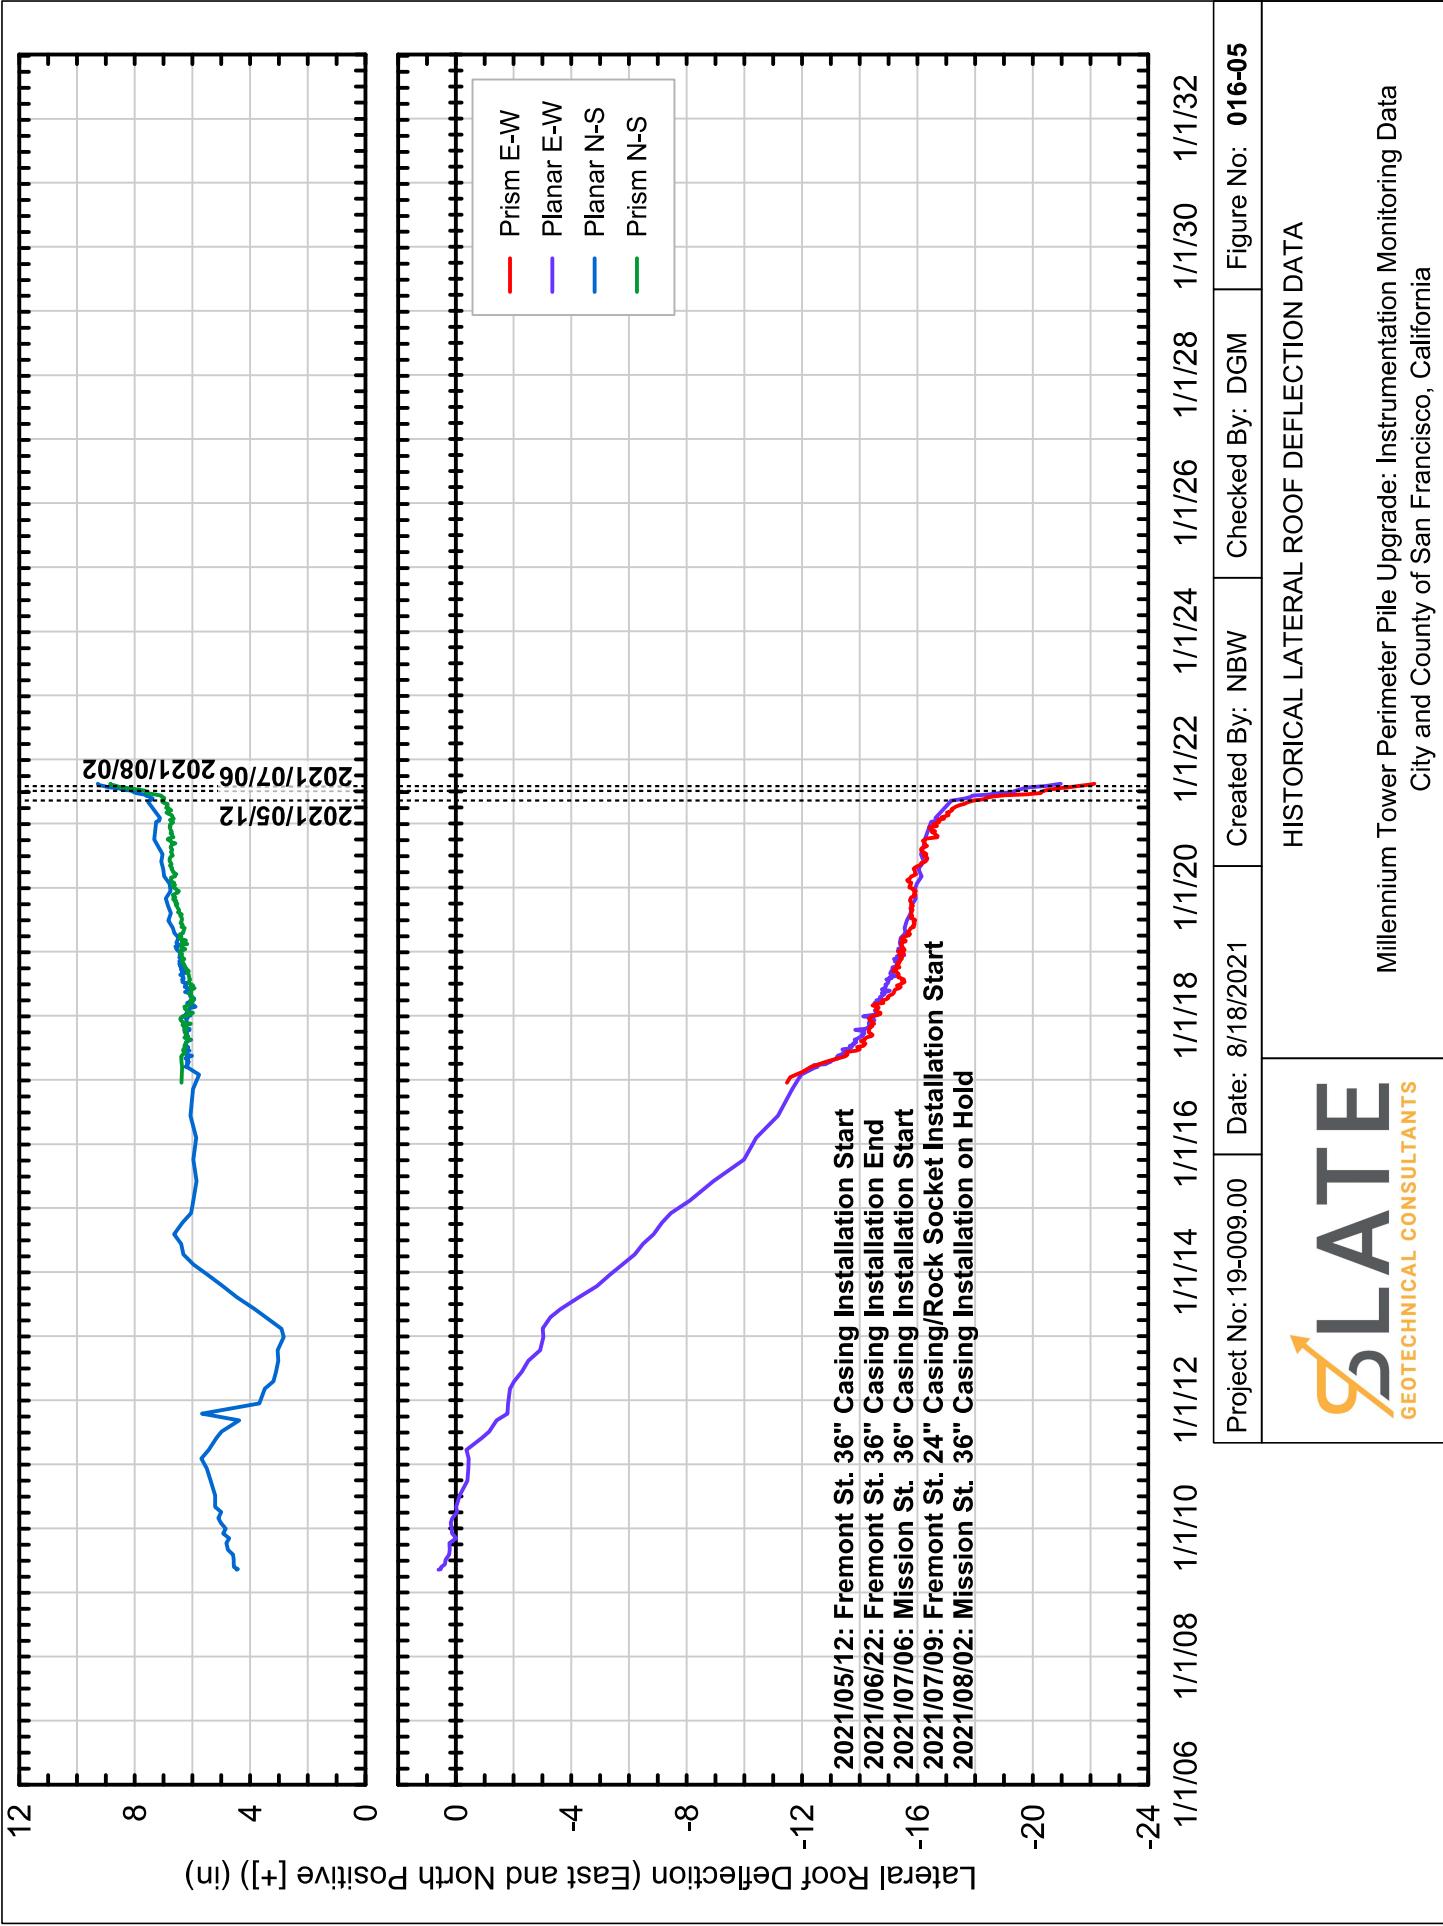
Figure 05 presents historical lateral roof deflections in the project north-south and project east-west directions interpreted from survey prisms mounted on the exterior of the Tower, from InSAR data, and from a planar fit of the settlement marker data. In addition, data from survey performed during the retrofit are included. Figure 06A presents differential lateral roof deflection data from a planar fit of the settlement marker data and from survey prisms mounted on the exterior of the Tower since the start of production pile installation (May 12, 2021; baseline readings on May 10 and 13, 2021, respectively) through August 16, 2021. Figure 06B presents differential lateral roof deflection data from a planar fit of the settlement marker data and from survey prisms mounted on the exterior of the Tower since January 11, 2021, through August 16, 2021.

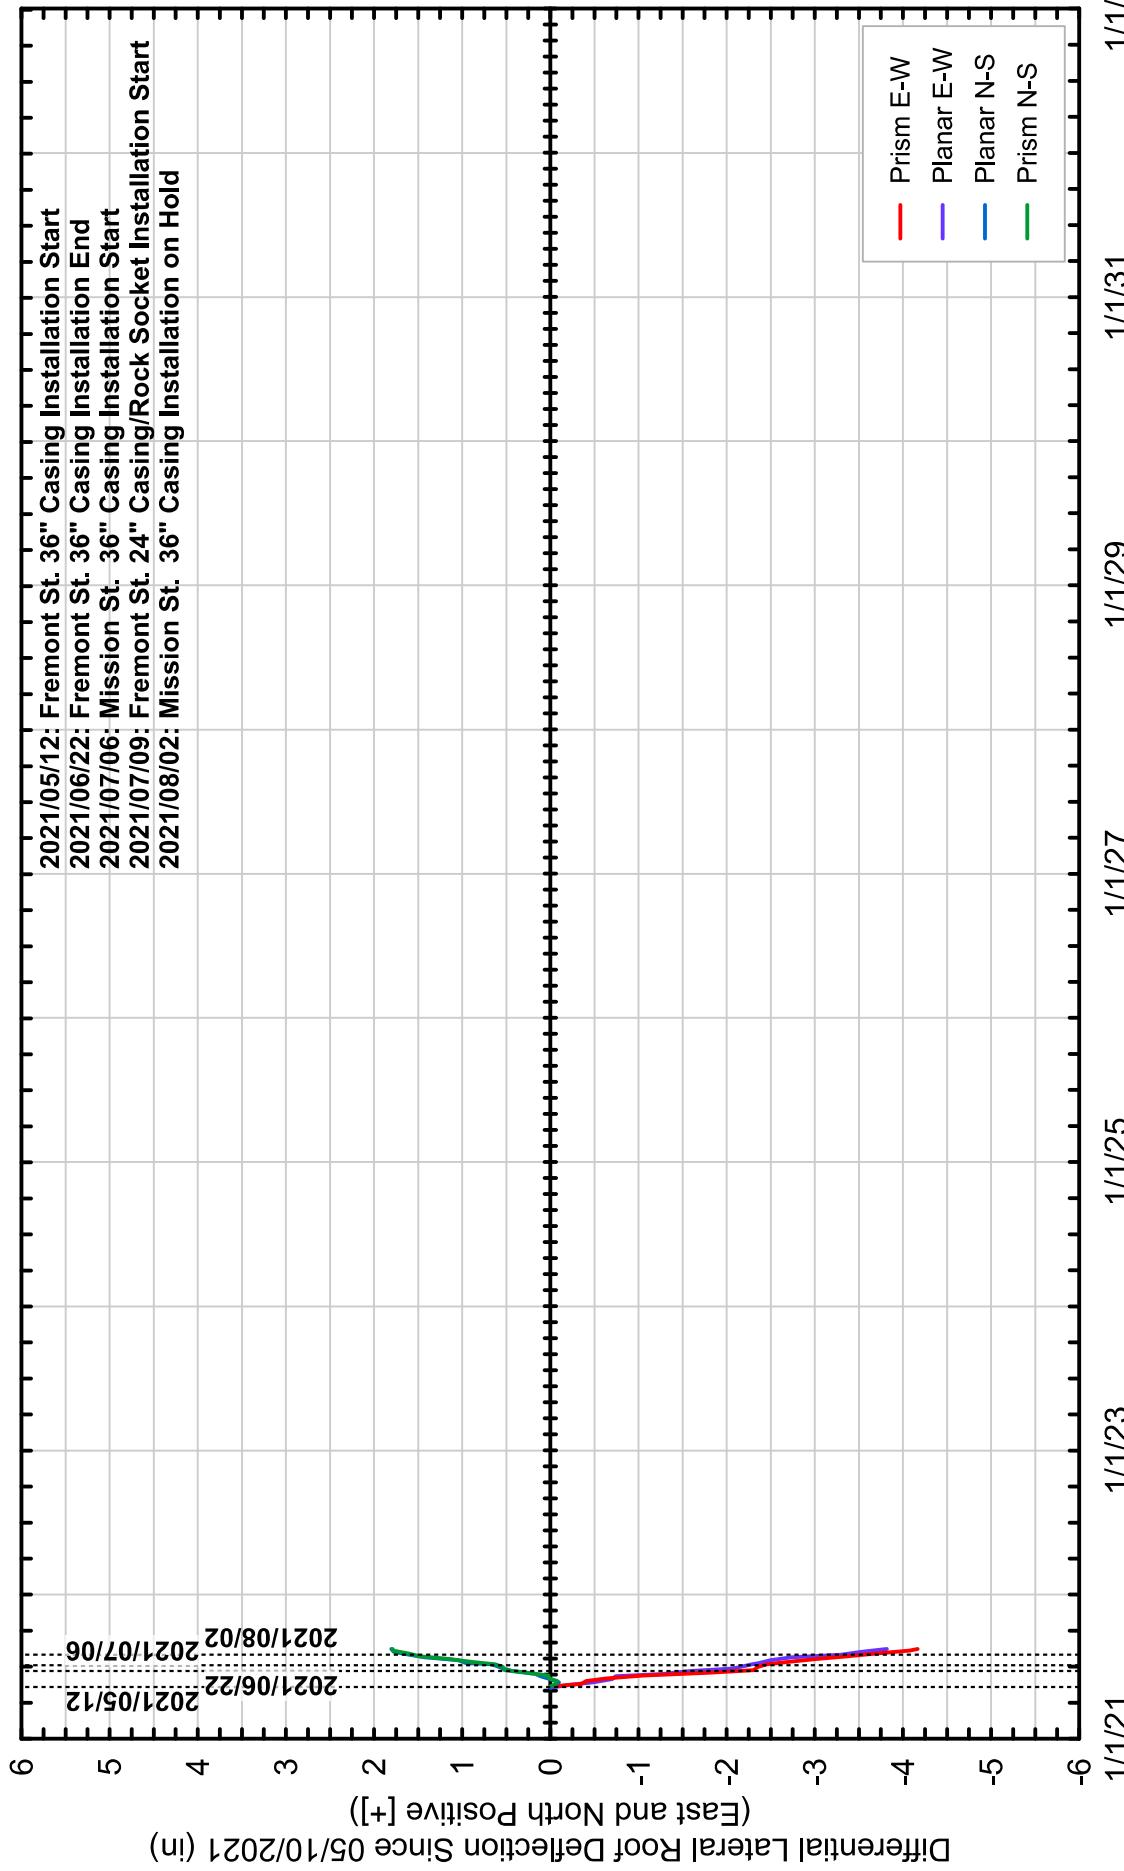
Project No: 19-009.00	Date: 8/18/2021	Created By: NBW	Checked By: DGM	Figure No: 016-06A
-----------------------	-----------------	-----------------	-----------------	--------------------

DIFFERENTIAL LATERAL ROOF DEFLECTION DATA
SINCE 05/10/2021 THROUGH 08/16/2021

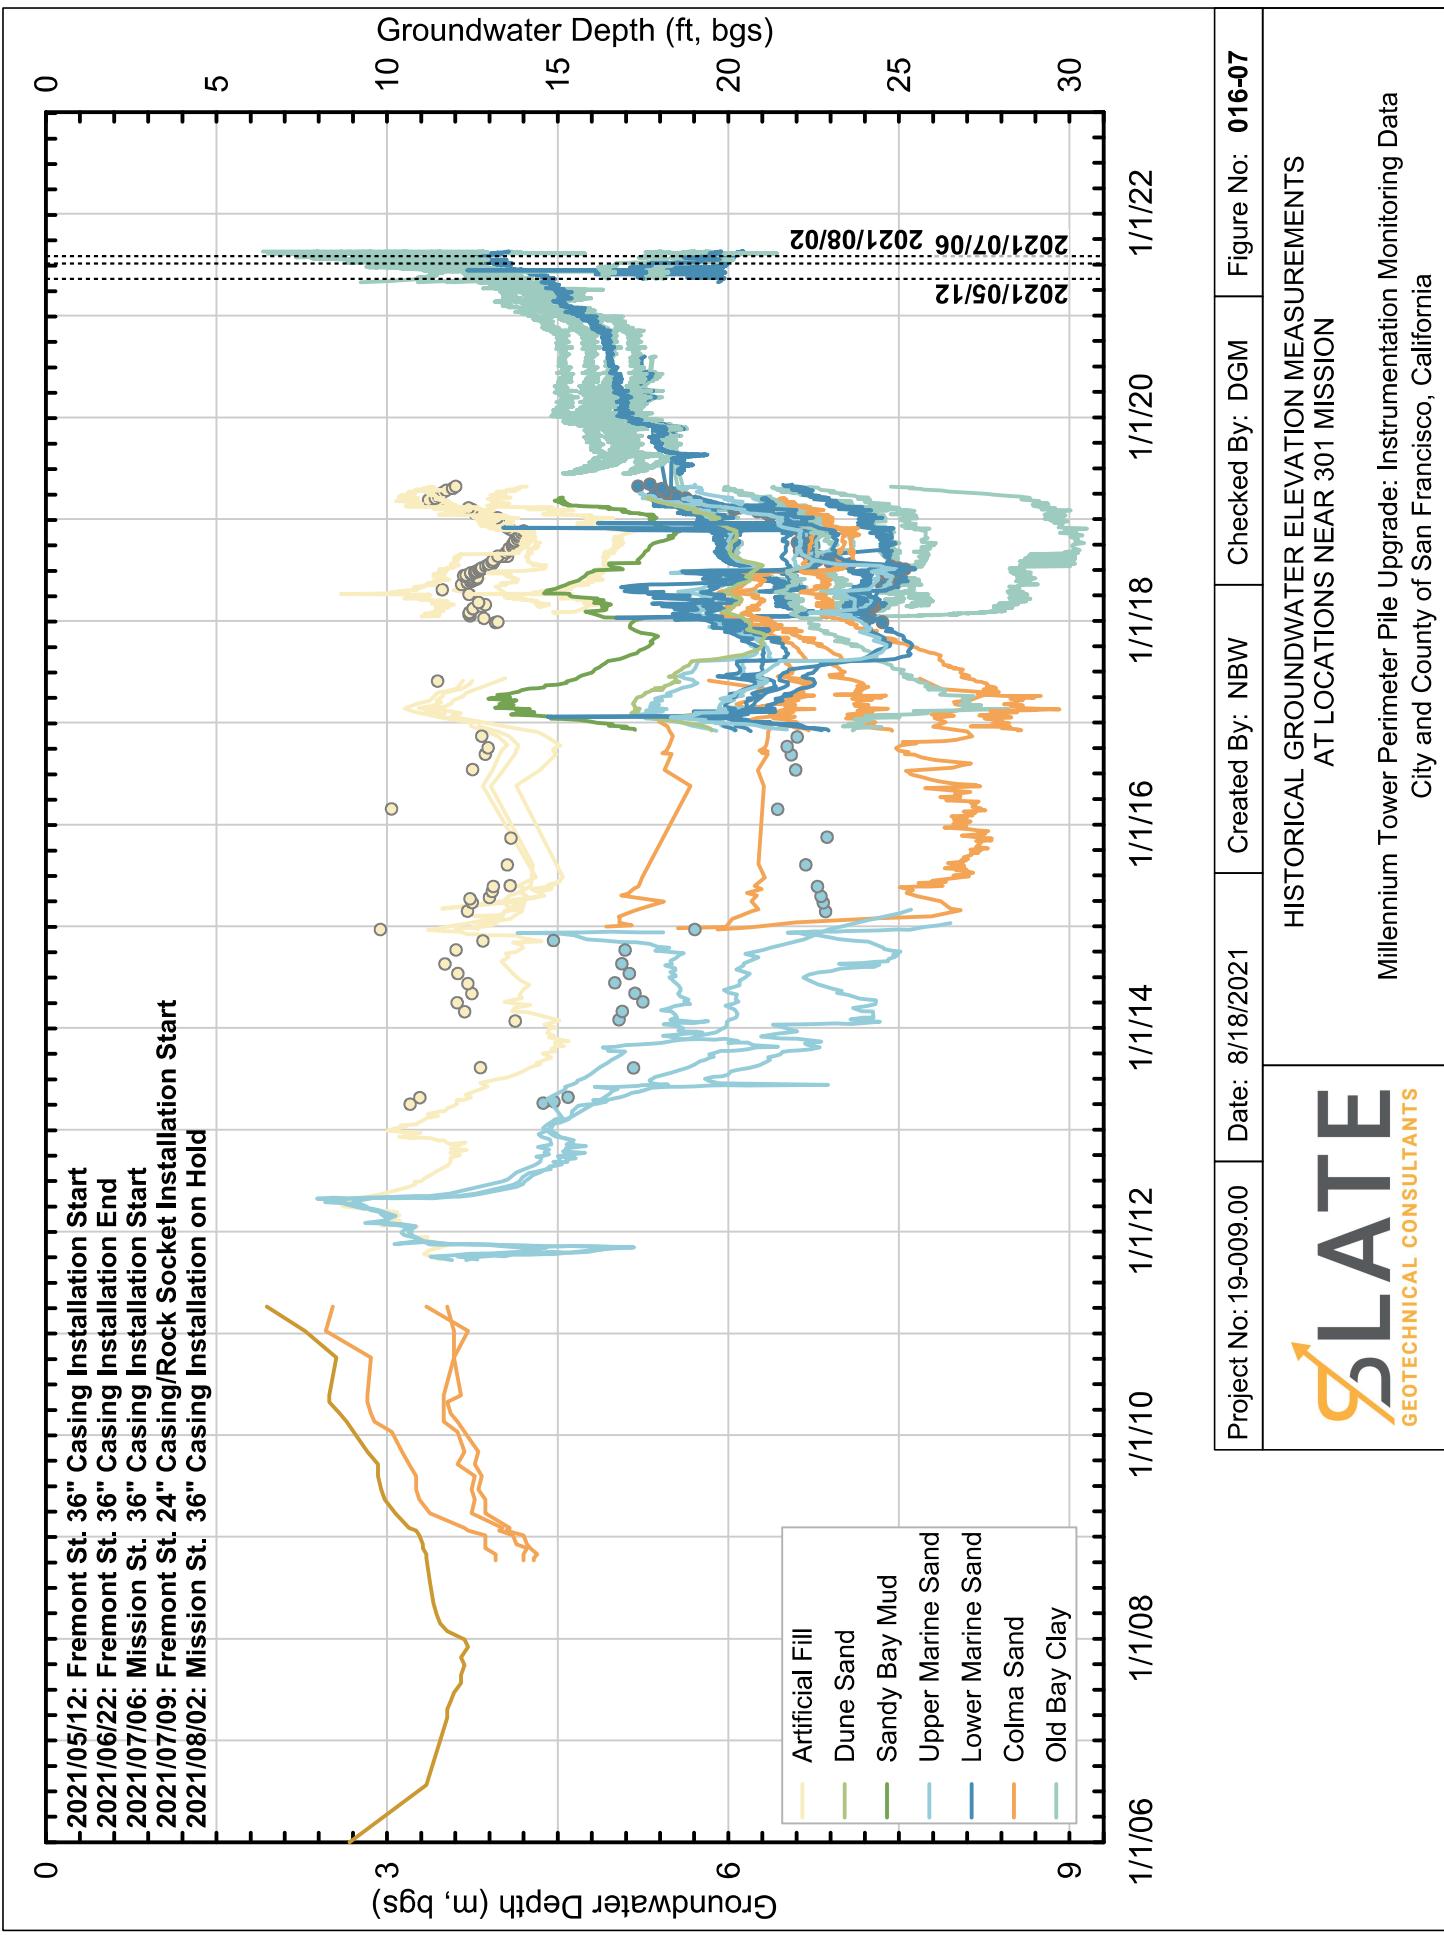
Figure 07 presents the historical groundwater elevation interpreted from piezometer readings at locations near 301 Mission. In addition, data from piezometers installed to monitor groundwater elevation during the retrofit are included. Figures 08 and 09 present groundwater elevation interpreted from piezometer readings in the Marine/Colma Sand and the Old Bay Clay, respectively, for the time period prior to the start of production pile installation (January 1, 2021) through August 18, 2021.

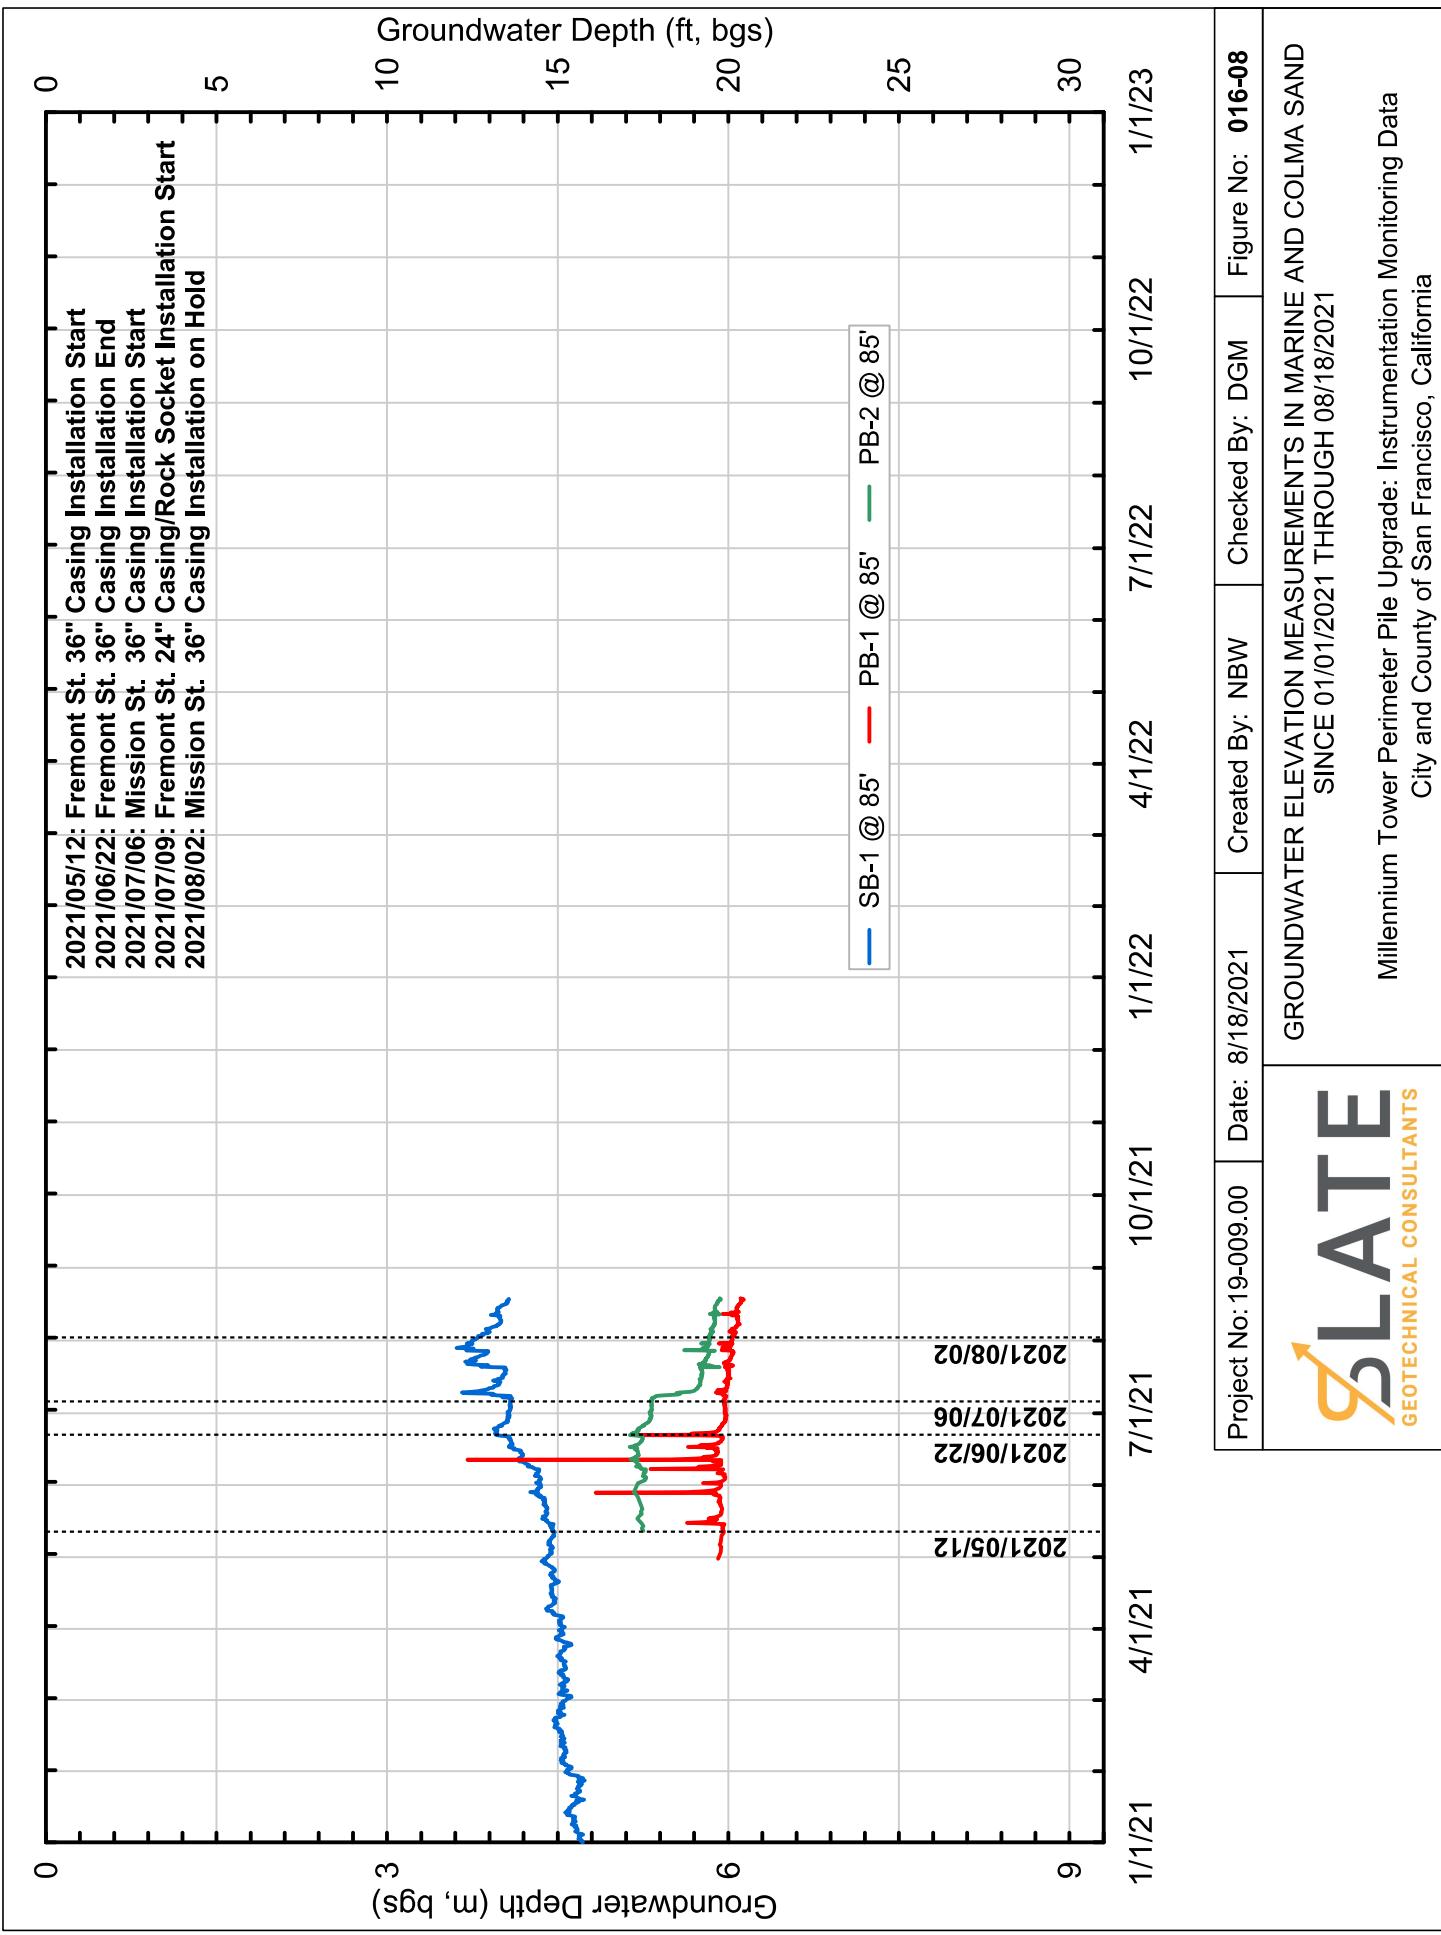
- Figure 08 – Groundwater Elevation Measurements in Marine and Colma Sand since 01/01/2021 through 08/18/2021
- Figure 09 – Groundwater Elevation Measurements in Old Bay Clay since 01/01/2021 through 08/18/2021

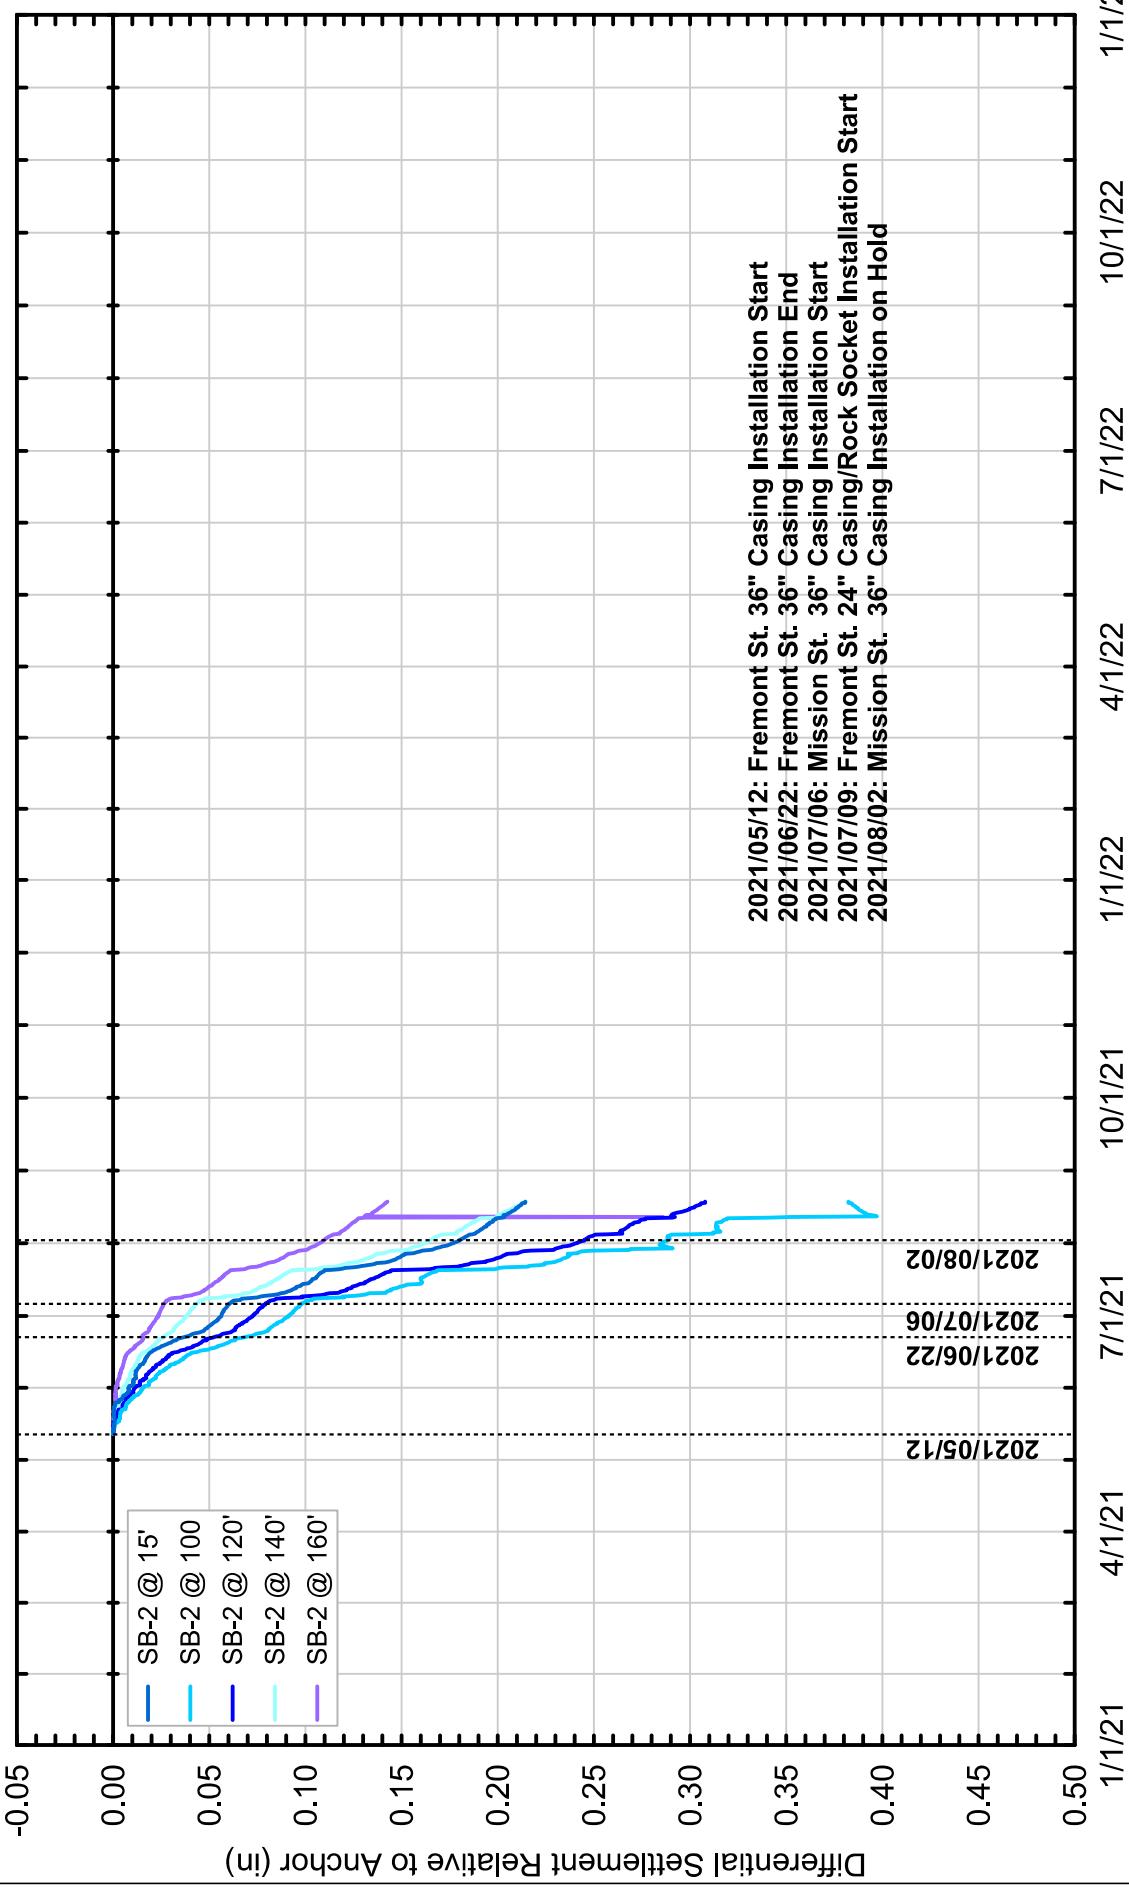
Figure 10 presents extensometer data from within the Tower basement since the start of production pile installation (May 12, 2021) through August 18, 2021. Figure 11 presents extensometer data from Fremont
